Final Report
Groundwater Intake Assessment

32 David Street
Spencerville, Ontario

Jp2g Consultants Inc.
1150 Morrison Drive, Suite 410
Ottawa, ON K2H 8S9
T 613.828.7800 F 613.828.2600
Jp2g Project No. 20-6109A

Township of Edwardsburgh-Cardinal
P.O. Box 129
Spencerville, ON K0E 1X0
November 9, 2020

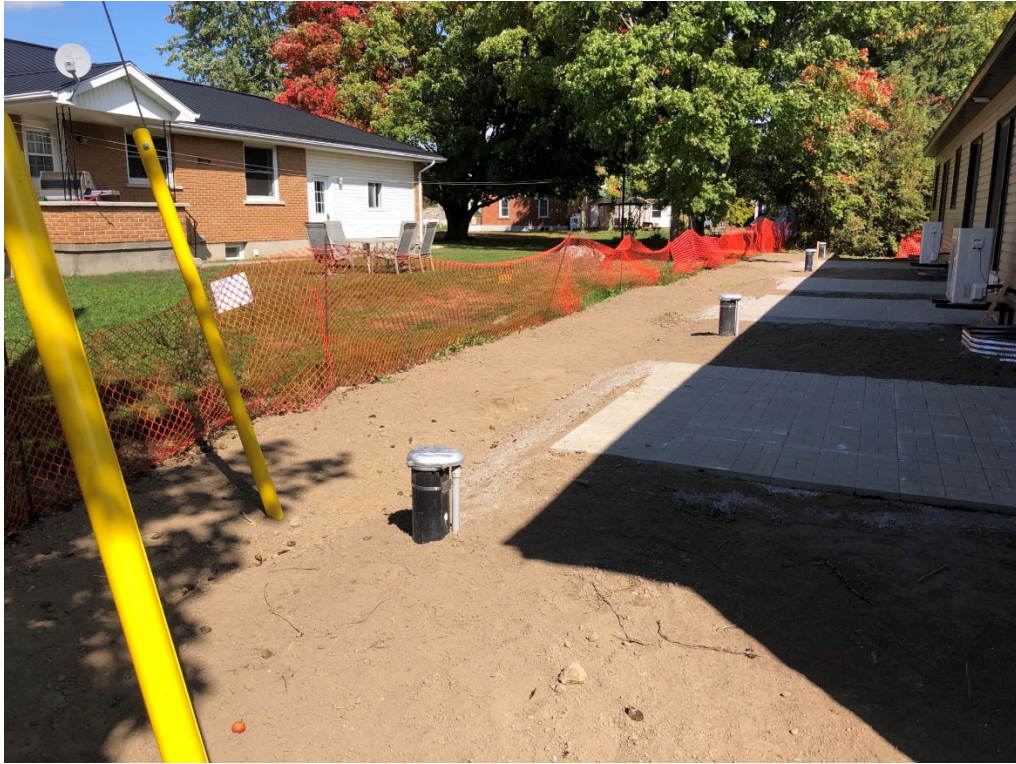
32 David Street, individual unit drinking well installations

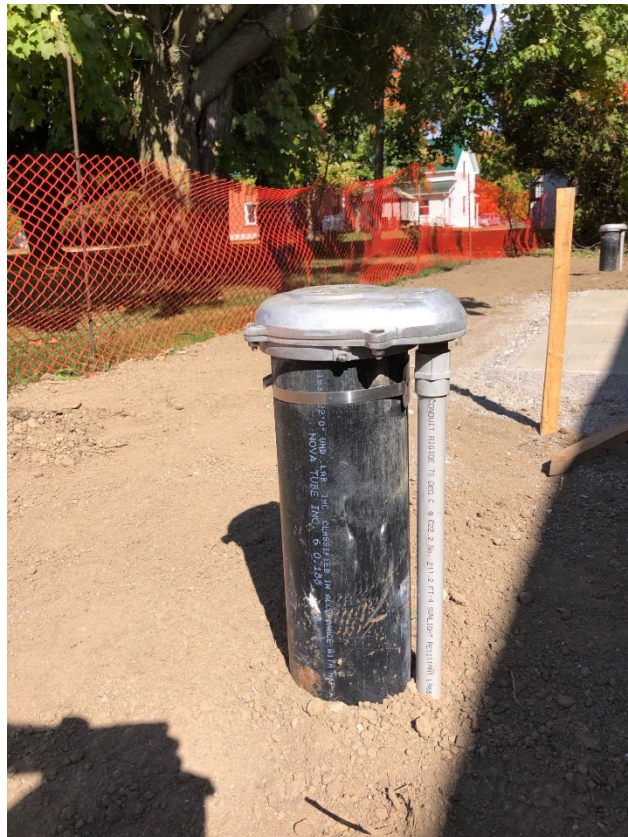
View of drinking well installation

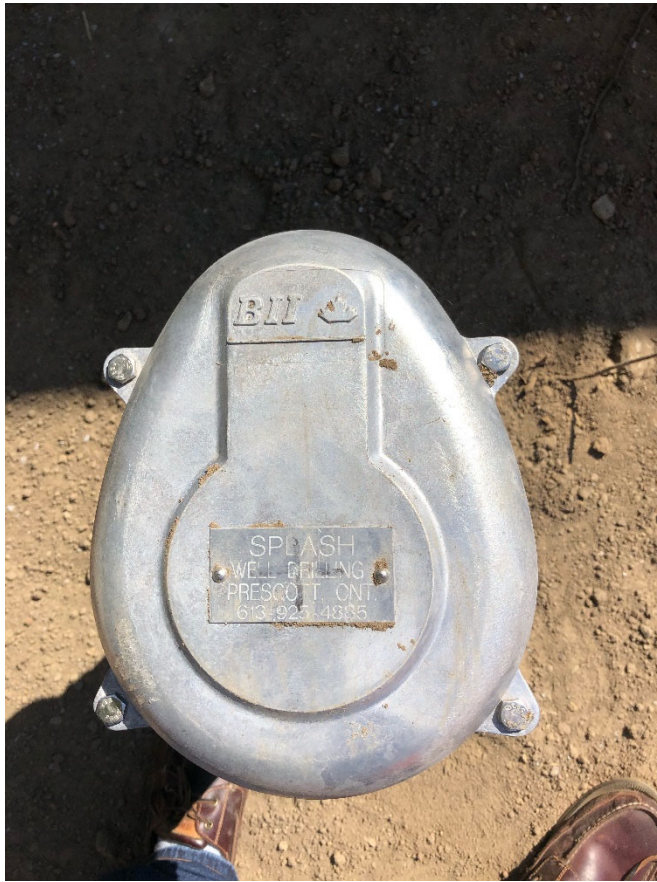
Well cap including details of drilling company

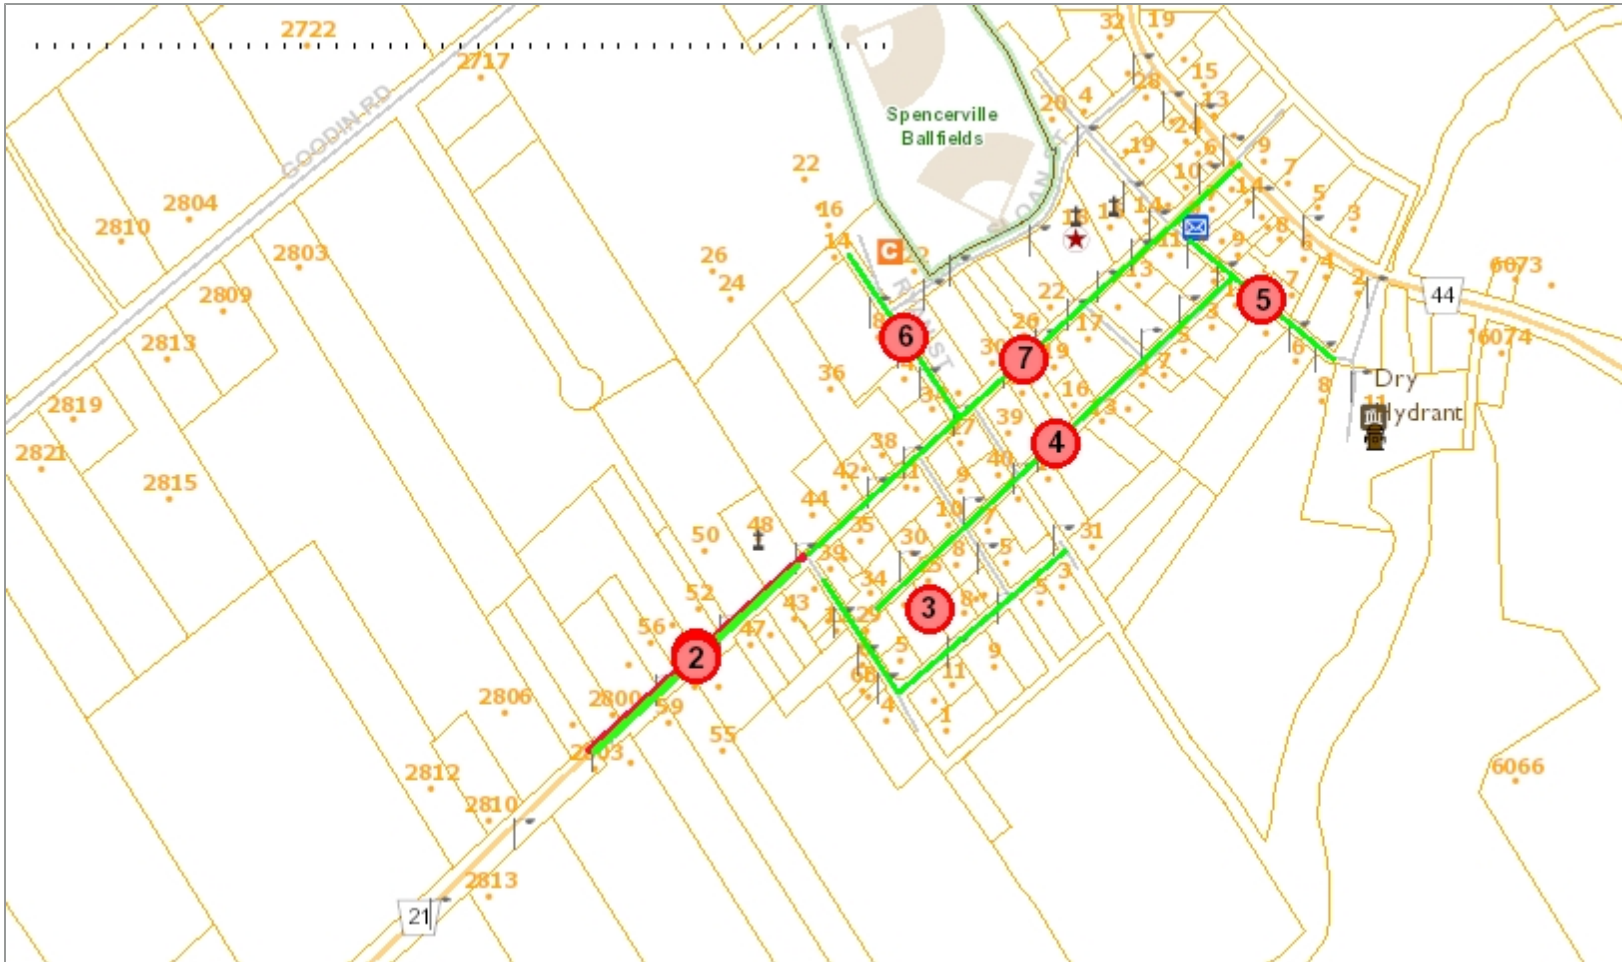
The Township inspected the sewer lines in August/September 2020 by Closed Circuit Television Video (CCTV) to detect any potential leak or faulty pipe. The lines inspected are shown in **Appendix B** and include the main sewer lines in proximity of the site and that run along Cedar, David and Centre Streets. The work revealed that two laterals to main gaskets were defective. The connections were excavated, and repairs were completed with no indication of external leakage.

COMMENTS Red - Force main Green - Sewer mains Note: Laterals on Ryan and Cedar St. were inspected

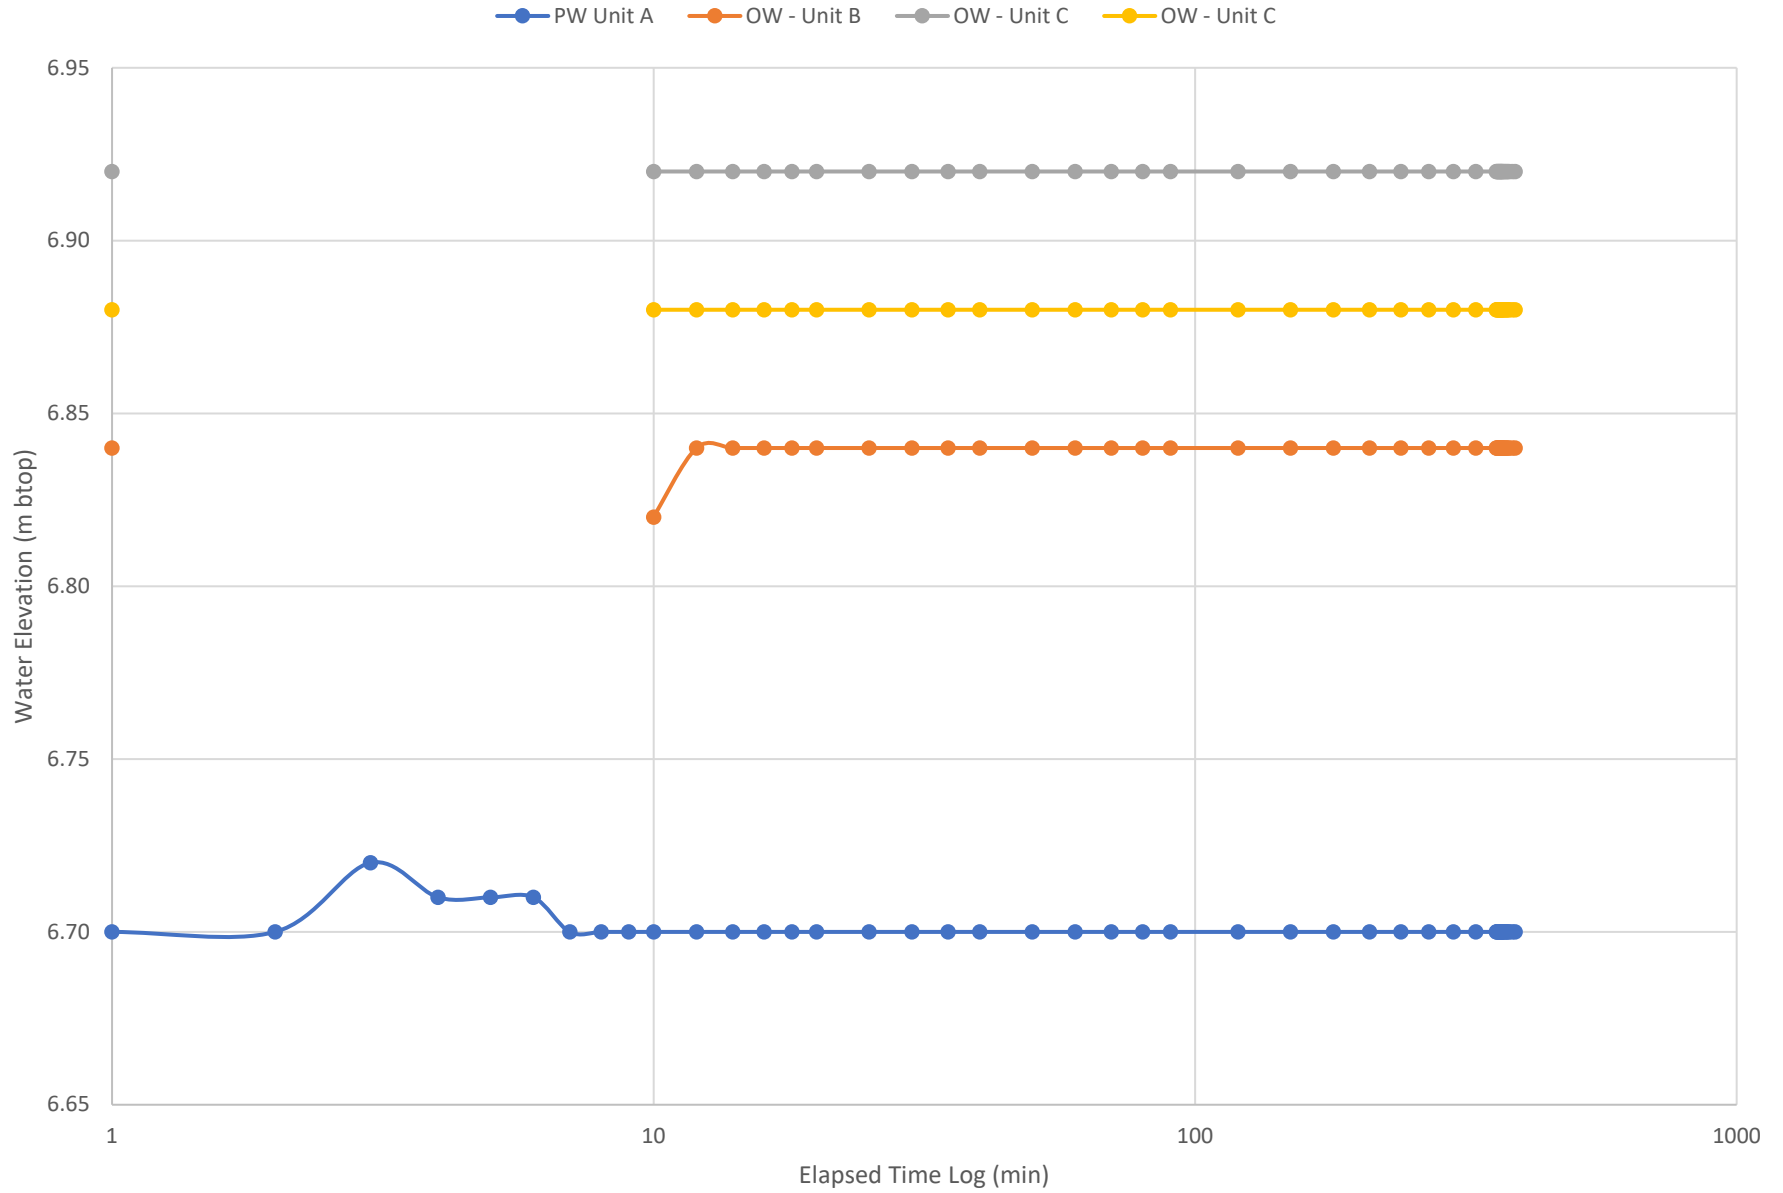
Chart 1: Water Level Response to Pumping of Unit A at 18.93 Lpm (5 U.S gpm)

Under the typical domestic rate of 18.93 Lpm (5 gpm), there was no interference recorded in the observation wells located on site between 6.30m and 24.57m from the pumping well. At double the typical domestic rate, interference in the order of 0.5% to 1.2% of the available fourplex wells drawdown was observed. The largest interference was within the pumping well and the lowest interference as at 17.48m from the pumping well. The pumping tests indicate that the minimum household demand of 5,000 litres per day could be met with complete recovery within a few hours. This is consistent with the high transmissivity values derived for the aquifer.

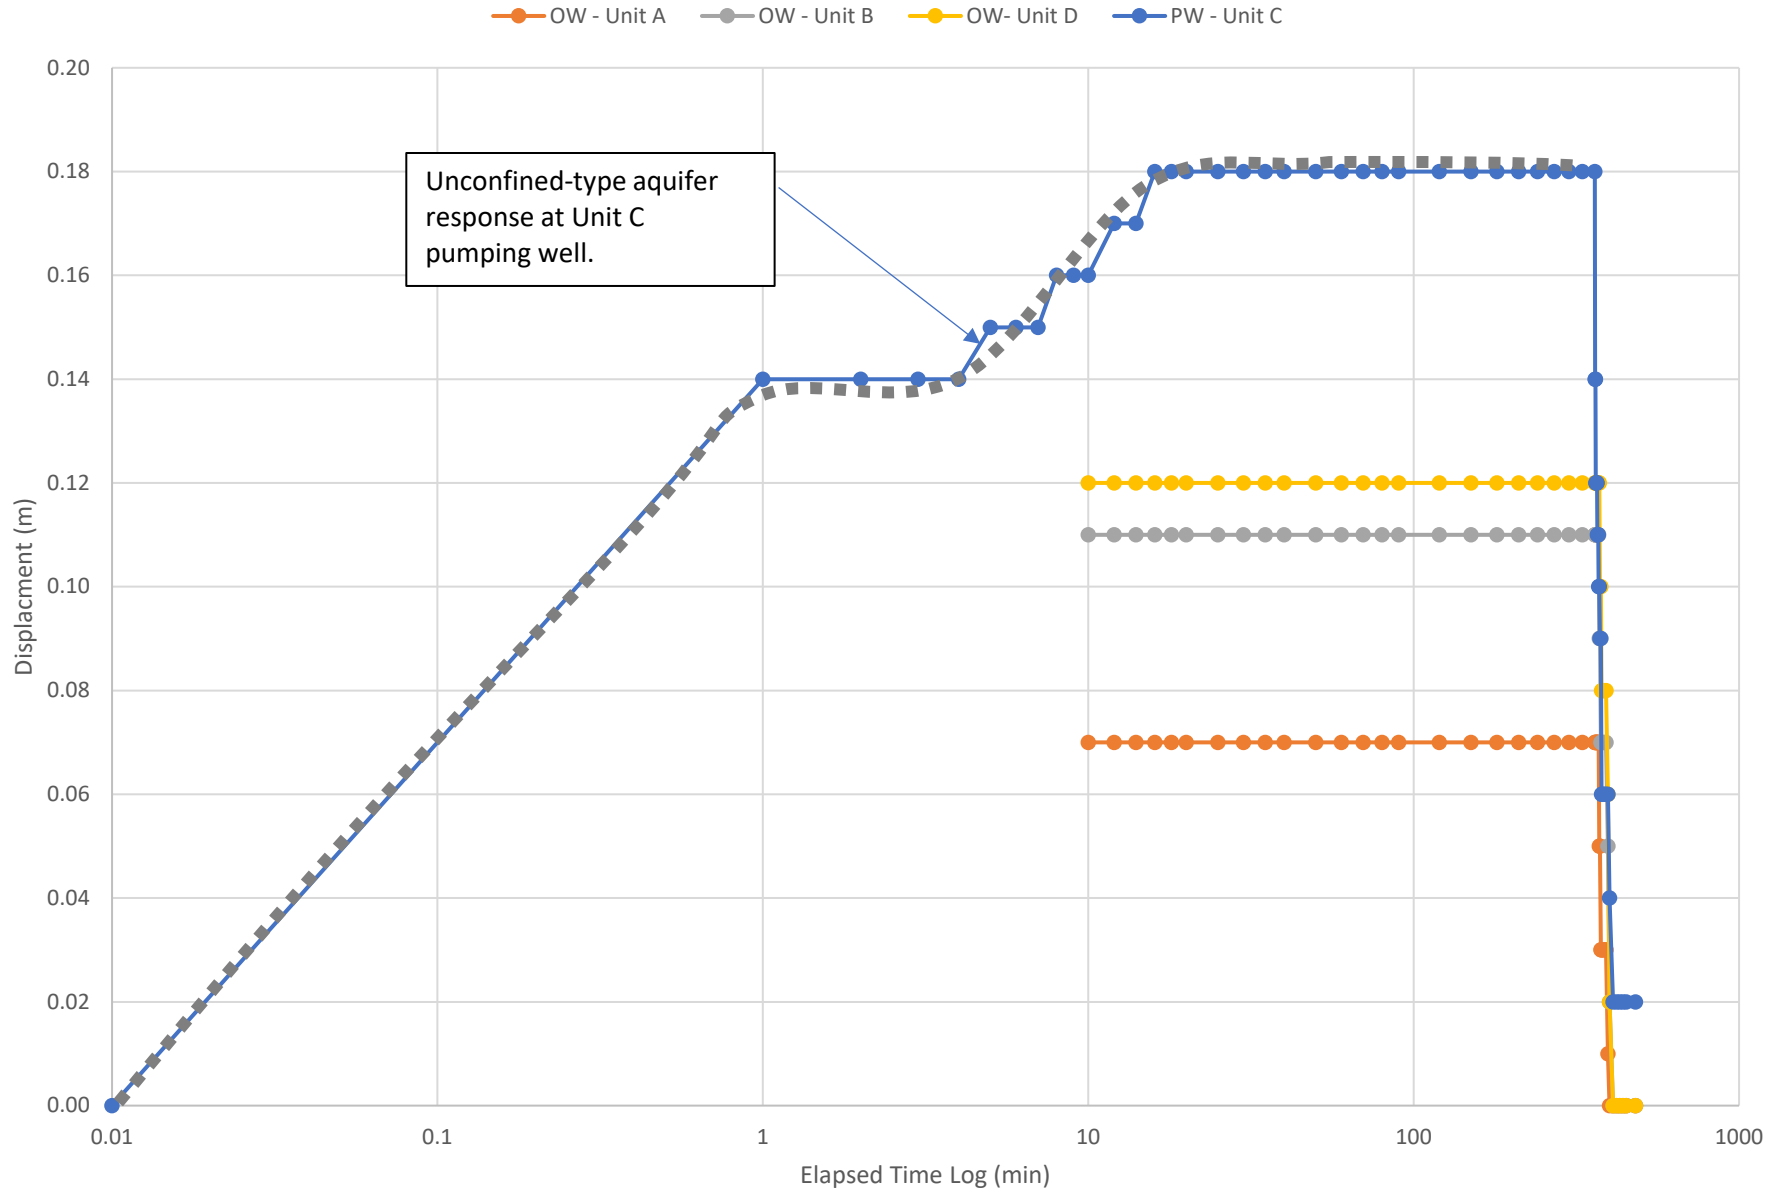
Chart 3: Water Level Response to Pumping of Unit C at 37.85 Lpm (10 U.S gpm)

The displacement curve for the Unit C well when subject to pumping is shown on **Chart 3**. An immediate storage release from the borehole and proximal fractures is seen in the first minute of pumping followed by a temporary stabilization period that is interpreted as a surge of flow to the fractures in response to pumping. The cone of depression continues to expand as pumping progresses until an equilibrium is reached and the flow to the well no longer requires a drop in hydraulic head. The first three sections of the curve are similar to the theoretical response to pumping of an unconfined aquifer or of a confined fractured aquifer. Unconfined solutions offer the best match to the displacement curves of pumping well C and observation well D and were used to estimate the hydraulic properties of the aquifer pumped at the fourplex. The curve matching program Aqtesolv Pro v4.5 was used. The input parameters are presented in **Table 1** and the results are summarized in **Table 2** and **Appendix C**.
